Pentagon Renovation and Terrorist Destruction Highlight Lessons Learned

The Renovation Saved Lives

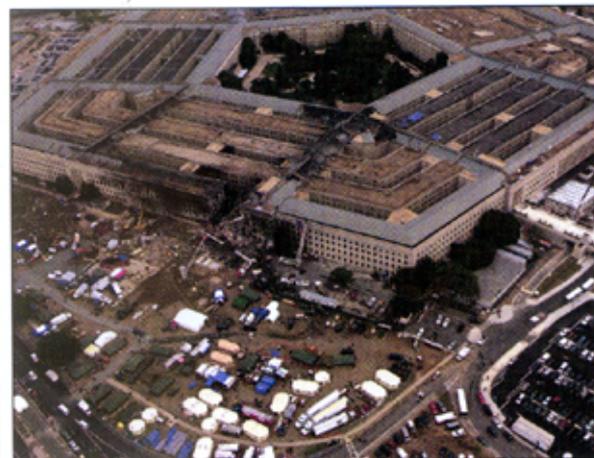
On September 11, 2001, a Boeing 757 struck the Pentagon's Wedge 1 on an angle and penetrated into an interior office ring in Wedge 2. Wedge 1 was just five days from completion, but the plane impacted areas that were only partially occupied.

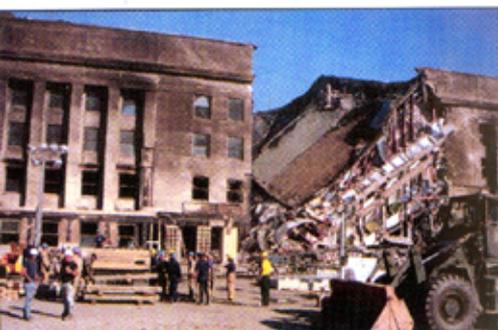
The old windows in Wedge 2 were shattered by the impact. Blast resistant windows in Wedge 1 were still in place directly above where the plane entered the Pentagon.

Despite the huge impact of the plane on September 11 and the resulting fireball that erupted as the plane's debris exited the C-ring, the blast resistant windows on the third and fourth floors, directly adjacent to the area which eventually

collapsed, remained intact. Several old windows in the not-yet-renovated Wedge 2 blew out. Lives were saved because of the steel reinforcement that surrounds the windows.

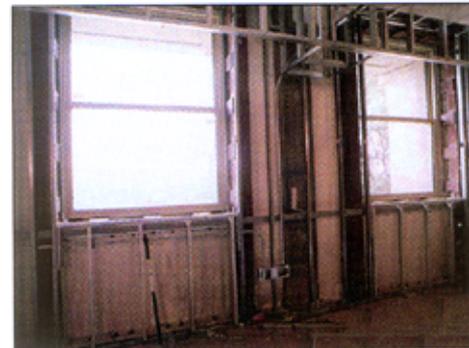
Exposed blast-resistant window

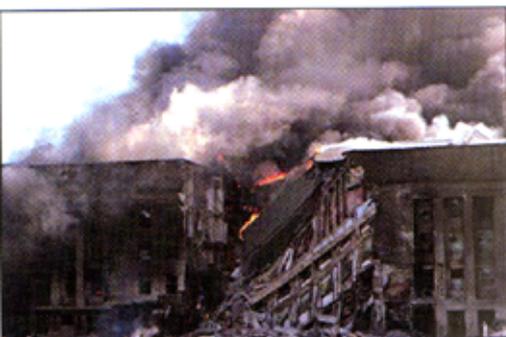
Flames rage through the Pentagon September 11, 2001.

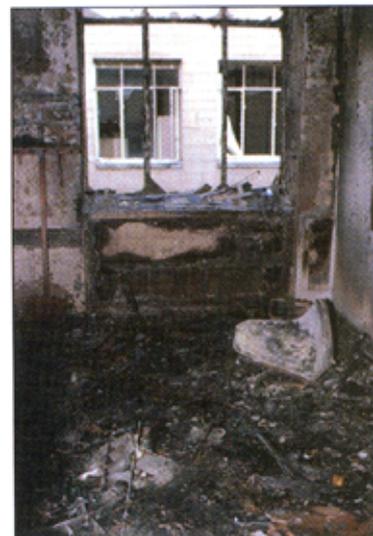
Damage inside an E-Ring office that lacked blast-resistant windows and steel reinforcement was much greater.
